Introduction

The Mombasa Project

For this project, the entire area of the island was audited, using the My Safetipin app, by a group of volunteers arranged by the Flone Initiative team. The aim of the project was to identify factors that could help improve the overall safety of the island.

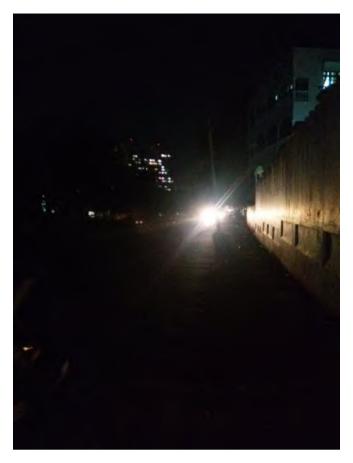
Image 1 showing street without any wokring streetlight

On most of these roads, it is found that there are patches where there is no streetlight, or the existing streetlights are not working. 59% of the audit points were rated Below Average indicating low lighting. There are over 600 points with this rating all over the city. Some prominent road stretches which have low lighting and require improvement are parts of Mombasa Road, Sheikh Abdullas F. Road, Moi Avenue and Nyerere Avenue. There are many streets near residential and suburban areas which also have low lighting.

- The existing streetlights that have been found non-operational need to be repaired.
- Streetlights need to be installed along the streets, identified as dark spots i.e. locations with no light.
- Pedestrian scale streetlights should be installed along the main roads so that the walkpath is well lit.

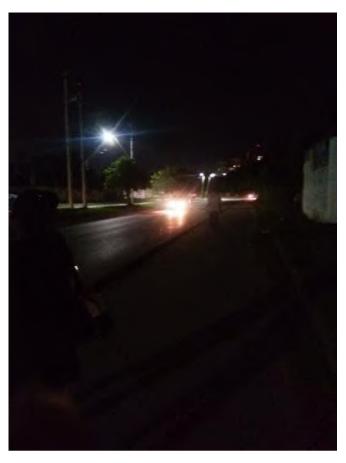
Image 2 showing one working streetlight on a road

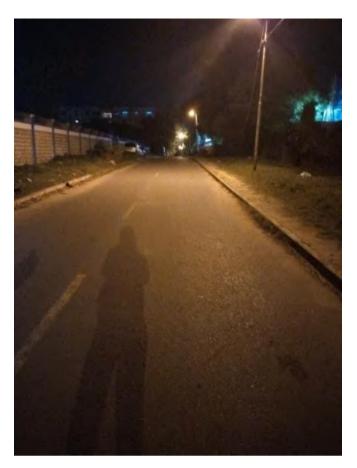
Image 4 showing walkpath covered with grass

It can be seen from Image 4 that there is a raised path but covered with grass making it difficult for the pedestrians. Some of the places where this can be seen are on Mathenge Road and Margaret.

- At points with unpaved walkpath, a proper paved footpath should be constructed, free of any obstruction.
- There is a need for segregated space for pedestrians and vehicles along all the roads.
 In case of narrow lanes, it should be marked clearly.
- At points as shown in Image 4, regular pruning should be done to maintain the walkpath.

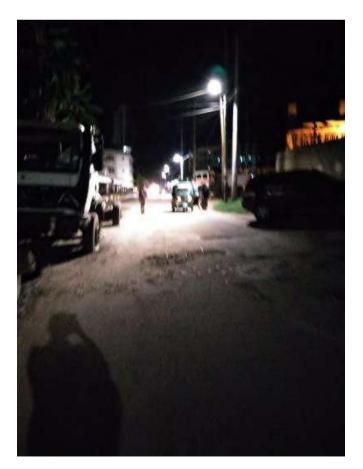
Image 6 showing no separate walkpath from road

Image 6 shows a road that has no segregated space for vehicles and pedestrians.

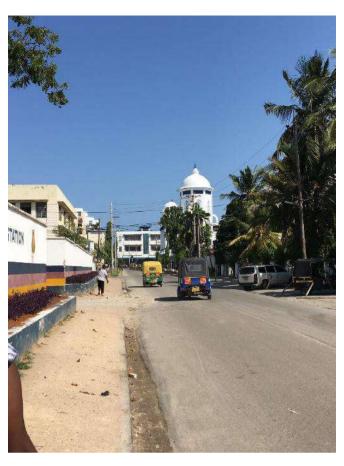
Image 5 showing unpaved walkpath

Image 5 shows an area where there is a walkpath, however, it is not well-maintained and is unpaved.

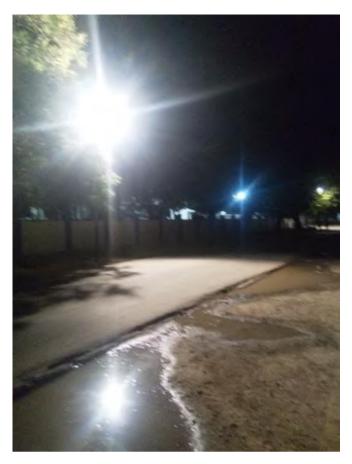
Image 7 showing high boundary walls

High boundary walls as shown in Images 7 and 8 can be found on stretches of Shimanzi Road which connects to Beira Road and Dedan Kimathi Road which connects to Kwale Road. The boundary walls acts as a barrier between the people on the street and built environment. It also results in making the street more inactive that instill a sense of fear in the pedestrians. Image 9 shows vendors on the street and the presence of women and children.

- The height of the existing boundary walls should be reduced to 1-1.5m and the remaining should be covered with grills so that there is a visual connection for the pedestrians at their eye level.
- Hawkers and vendors along the streets act as a natural surveillance and should be encouraged in the city. There should be designated hawker zones on the streets for them.

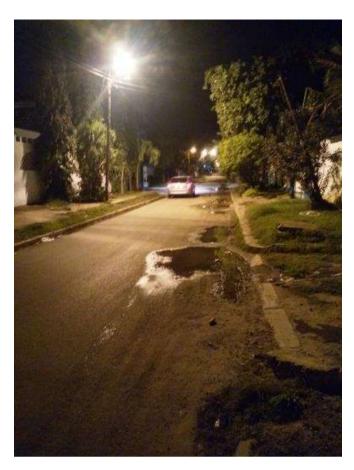
Image 8 showing high boundary walls

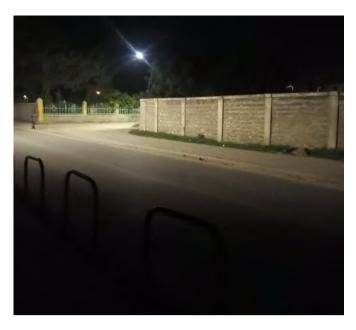
Image 10 showing high boundary wall and no security

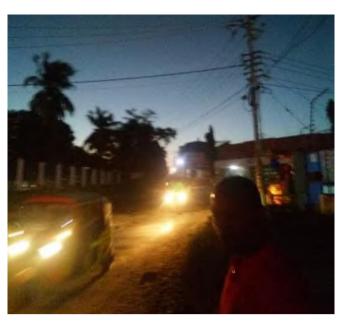
Additionally, the volunteers who conducted the safety audits have mentioned in the comments that many of these areas have non- functional streetlights. For the transport stops, it is important to have proper lighting and walking infrastructure. Street furniture should also be provided for commuters.

Image 11 showing public transport and no streetlights

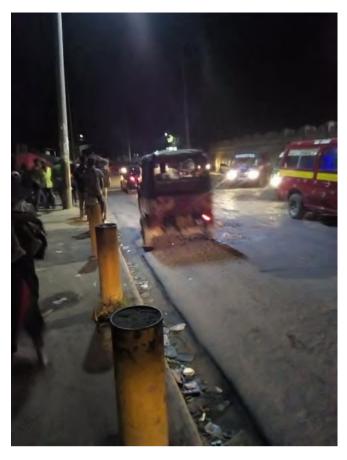
Image 12 showing tuk-tuks with no proper place for stopping

- Existing matatu stops should be provided with proper shelter. They should be well-lit and have adequate seating for the commuters. Interactive panels indicating routes, emergency helpline numbers and an emergency button for help or distress should be provided at the bus stops.
- Designated tuk-tuk stands should be set up with proper space for parking.
- The streets around these stops should have space for vendors and hawkers around them.
- Though access to public transport is good in Mombasa, there is a need for gender sensitization within the network as from the Baseline study conducted by Flone Initiative.

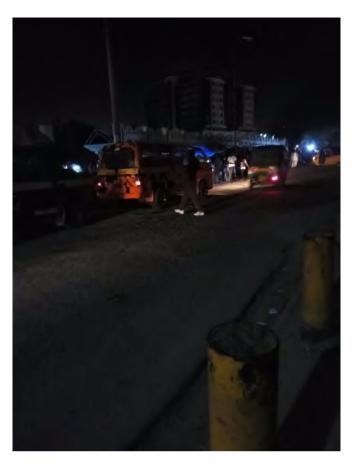
Image 13 showing matatus with no proper place for stopping

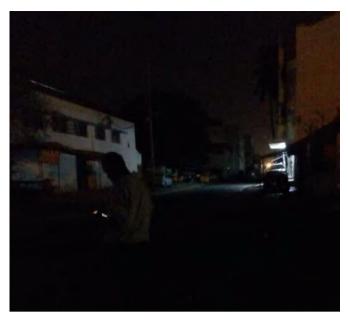
Image 16 showing a street with no streetlights

These identified spots should be dealt with on priority so as to promote more women and children to use the public spaces and make these spaces more active and lively. Lighting has been found to have a high impact on the feeling of safety and hence, should be addressed as a priority for infrastructure improvement.

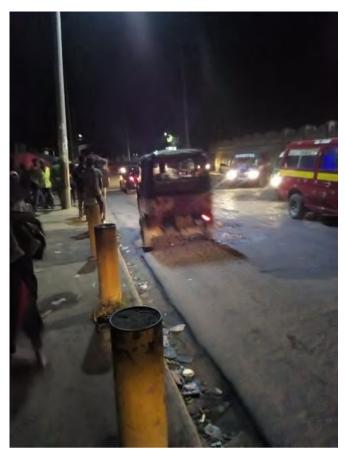
Image 17 showing no women near public transport

- There should be Awareness campaigns and streets activities arranged which promote women and girls in public spaces so they feel comfortable using public spaces.
- There should be gender sensitization training within the public transport sector to promote more women in the industry.
- Infrastructure in public spaces, like seating and lighting need to be improved so it proves to be a welcoming environment for more women and children to use.

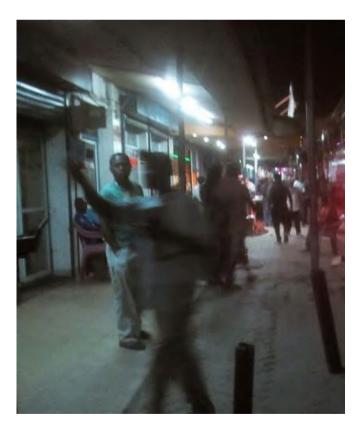
Image 19 showing few/no women in a public space

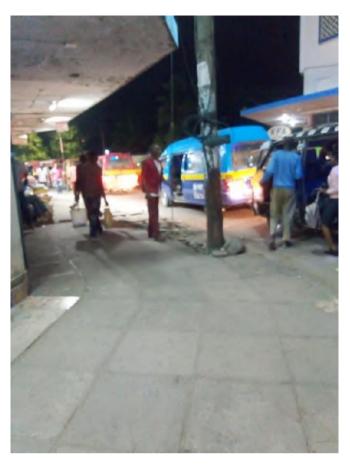
Image 18 showing no women near public transport
