# ABC

Place

Accessibility Audit Report

June 2024

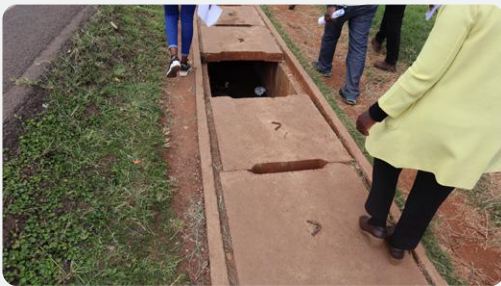
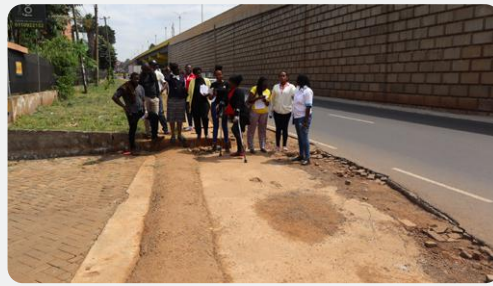
1. Vehicles partially park on the footpath, this forces pedestrians especially persons with mobility impairments to disembark on the footpath and utilise the carriageway for a smooth transition. This also creates obstacles for the visually impaired as they negotiate footpaths regarding footpath kerbs.
2. Poor maintenance of the footpath, for instance, some of the drain slabs along the section have sunk or gone missing in some sections, creating barriers and safety hazards for pedestrians especially those with visual impairments and mobility impairments.
3. The designated footpath has spacing between the drain covers creating obstacles for the physically impaired especially those using crutches or strollers and visually impaired pedestrians who use white canes.

Establishing raised kerb lines, and traffic bollards between the pedestrian footpath and the carriageway is an effective measure to prevent motorists from parking on the footpath. Bollards work to create physical barriers that discourage motorists from encroaching on pedestrian spaces.

Installation of bollards to prevent vehicles from parking on footpaths, with a spacing of 900mm between at least one set of bollards to allow wheelchairs to pass.

Erect parking restriction signs that prohibit Parking on the pedestrian walkways.

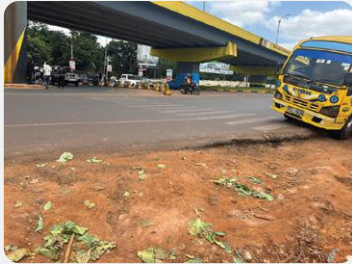
1. The absence of tactile paving at pedestrian crossing points prevents people with visual impairments from easily identifying road crossings.
2. The tendency of public service vehicles to park at the crossing points blocks the view of traffic at crossing points creating a safety hazard, especially for children and individuals with mobility challenges as they may be unable to see oncoming traffic and drivers may not see them until it's too late.

3. The absence of pedestrian crossings at designated bus stops poses a significant safety risk as pedestrians are forced to cross the road in unsafe areas, increasing the likelihood of accidents, especially when pedestrians need to access the bus stop in a hurry.

4. The presence of curbs at the end of the crosswalk, for instance, along ABC Place creates a barrier to access for pedestrians, especially those with mobility impairments or those using strollers. The curbs do not offer a direct connection to the footpath, forcing the pedestrians to find alternative ways of accessing the footpath, which increases the risk of trips and falls.

1. Establishing at-grade pedestrian crossings which aims to provide universal access aiding in the smooth transition for persons with mobility impairments from the footpath and onto the crosswalk and vice versa.
2. Ensuring that pedestrian crossings are marked in a highly conspicuous and visible manner is important, especially for pedestrians with low vision.
3. Installation of tactile paving at pedestrian crossings to assist pedestrians with visual impairments in easily identifying the road crossing points.
4. Clear sightlines are essential for safe crossings, and ensuring that parked cars do not impede visibility is crucial for pedestrian safety.

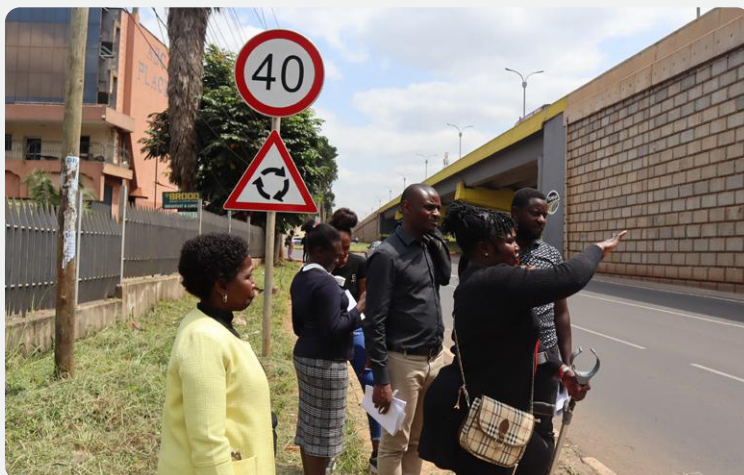
1. Drivers fail to yield to pedestrians at the designated pedestrian crossing leading to increased risks of accidents and fatalities with the vulnerable groups being most at risk.
2. Drivers drive too fast along the highway, which reduces their time to see, process and react to pedestrians crossing the road, Persons with disabilities are the most at risk, especially those with hearing and visual impairments as they cannot see incoming vehicles or hear hooting from oncoming motorists. Pedestrians with mobility impairments are also at risk as they spend a considerable amount of time crossing the road compared to pedestrians without disabilities, putting them at great risk.
3. Drivers drive too close to pedestrians, which increases the likelihood of accidents and heightened anxiety, especially for persons with disabilities and older persons who are most at risk.

It is important to install speed limit signs at the road section (between 50 and 100 m) intervals to alert drivers to slow down as they approach the pedestrian crossing.
