Introduction

The Mombasa Project

For this project, the entire area of the island was audited, using the My Safetipin app, by a group of volunteers arranged by the Flone Initiative team. The aim of the project was to identify factors that could help improve the overall safety of the island.

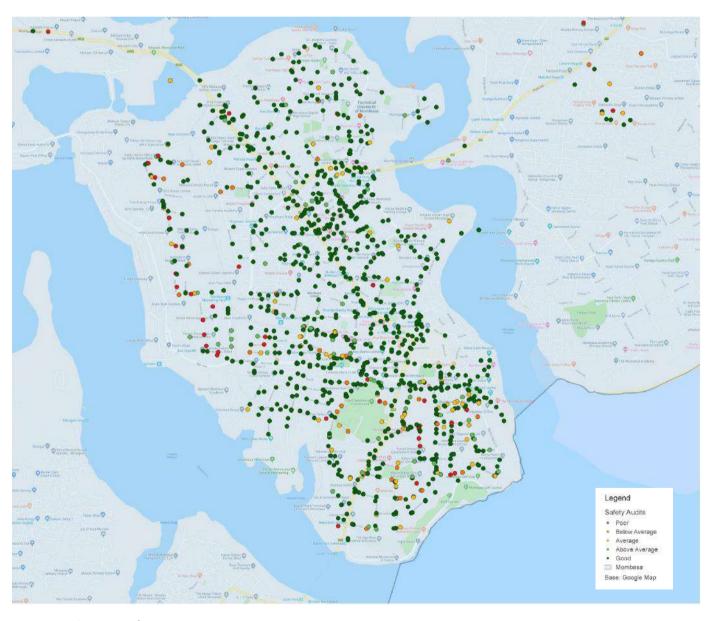
Map 1 indicating Safety Score rating

The Safety Score of a point is a reflection of the perception of safety at that particular location. For each audit point, a value between 0 and 5 is given, 0 being Poor i.e. very unsafe and 5 being Good in terms of overall safety. Indicated in the pie chart is the percentage distribution of pins in each range. Only 4% of the audit points were rated poorly, which implies a safety score less than 1 out of 5. As seen in the Safety Score map below, these points are located on Kwale road, Zanzibar road and the junction between Shimanzi road and Beira road. 76% of the audit points have been rated as good which covers the central region of the island.

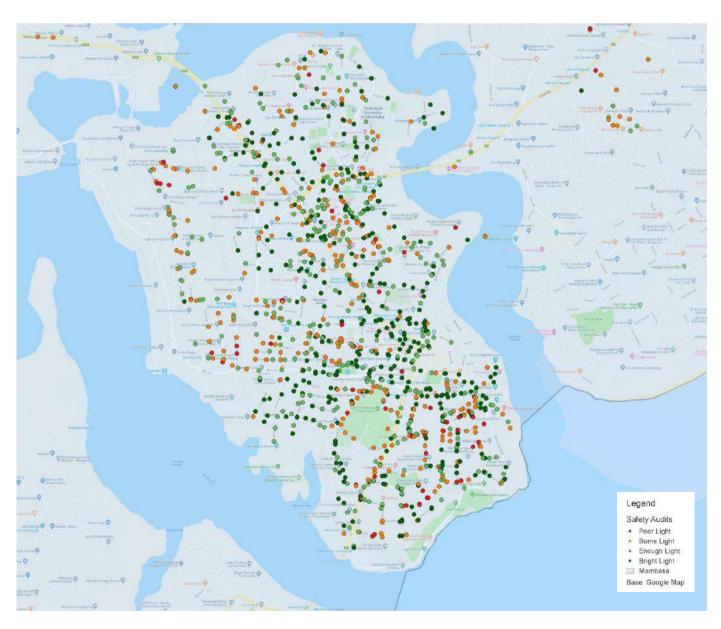
Map 2 indicating Lighting rating

The lighting in Mombasa has been rated 1.9/3 which is Average. 3% of the audit points have been rated Poor indicating that these areas have no light. Few of these dark spots, i.e. areas without light are some points on Unga Street, Mozambique Street, Dedan Kimathi Avenue and Kaunda Avenue. This can be seen in Map 2 below indicated by all the points that are marked red.

On most of these roads, it is found that there are patches where there is no streetlight, or the existing streetlights are not working. 59% of the audit points were rated Below Average indicating low lighting. There are over 600 points with this rating all over the city. Some prominent road stretches which have low lighting and require improvement are parts of Mombasa Road, Sheikh Abdullas F. Road, Moi Avenue and Nyerere Avenue. There are many streets near residential and suburban areas which also have low lighting.

- The existing streetlights that have been found non-operational need to be repaired.
- Streetlights need to be installed along the streets, identified as dark spots i.e. locations with no light.
- Pedestrian scale streetlights should be installed along the main roads so that the walkpath is well lit.

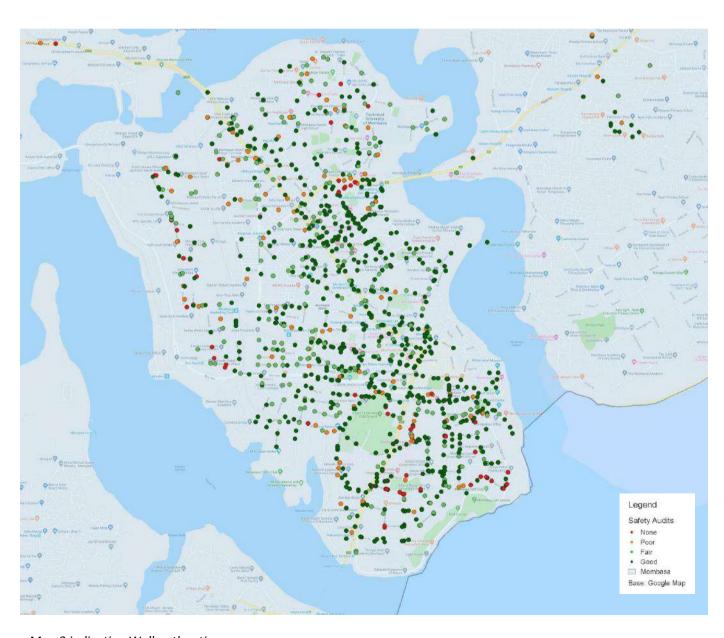
Map 3 indicating Walkpath rating

Walkpath, the highest rated parameter for Mombasa has been rated 2.4/3 which is Good. This indicates that there is a paved walkpath for pedestrians to walk at most places in Mombasa. 14% of the audit points, however, have been rated low. These are some residential areas and narrow roads that don't have a designated path for pedestrians and the road is shared by the cars and pedestrians.

SNo.	Walkpath Issues	Street Name	Recommendation
1	Unpaved or broken walkpath	Mogadishu Road Dar Es Salam Road Makande Road towards Shimanzi Road	There is space for a walkpath present on these roads, however, it is unpaved or broken. These walkpaths need to be repaired and paved.
2	Maintenance of walkpath	Margaret Road Mathenge Road 3 Mikindani Road Voi Street Opposite D.T Dobie, Tudor - Mwisho, Tom Mboya Rd	There is grass on both sides of the road obstructing the space for walking. Proper maintenance of these walkpaths should be scheduled for ease of walking in these areas. This can be done by trimming the grass or have a certain portion of the walkpath free of grass.
3	Designated space for walkpath	Ronald Ngala Road Wakauma Avenue Nelson Mandela Avenue Junction Nelson Mandela Avenue - Obote Avenue Junction	There are roads, paved and unpaved, where there is no proper distinction between the space for cars and the space for pedestrians. A proper divide should be created with a walkpath that is properly paved.

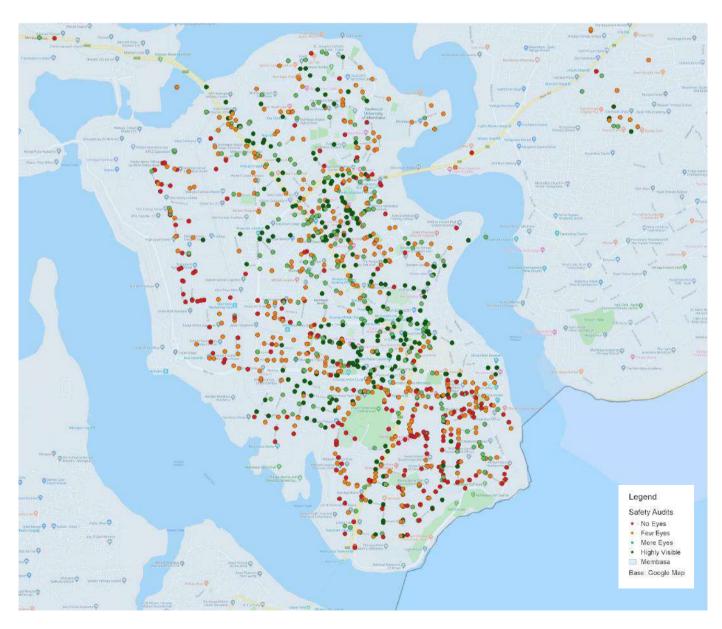
Map 4 indicating Visibility rating

Visibility for Mombasa has been rated 1.4/3 which is Average. 19% of the audit points have been given a low rating. As can be seen in the map below, the southern part of Mombasa island has very low visibility. This is mainly due to the presence of high boundary walls and wide roads.

SNo.	Visibility Issues	Street Name	Recommendation
1	High boundary walls and lack of activity	Koinage Road Makaburini Road Mosque, Nyerere Avenue Dedan Kimathi Road Kaunda Avenue	There height of the boundary walls in these areas is too high and creates a division between the people on either side of the wall. The height of the walls should be made lesser so that there are more "eyes on the street". This can be done by adding grilles to the top of the walls instead of having them at the current height. These streets can also be made more active by the addition of vendors and hawkers along side the walkpath so as to promote active streets.
2	Low Security and poor visibility	Mbaraki, Kwale Road Mogadishu Road, Moi Avenue Shimanzi, Makande, Masai Street Narok Road Near Mvita Grounds, Baringo Road	These streets have low natural and security surveillance. Both of these should be improved. Natural surveillance can be improved by the addition of more hawkers and vendors to make the streets more active. Security surveillance can be improved by the addition of these streets to police patrolling routes, CCTVs cameras and more police personnel.

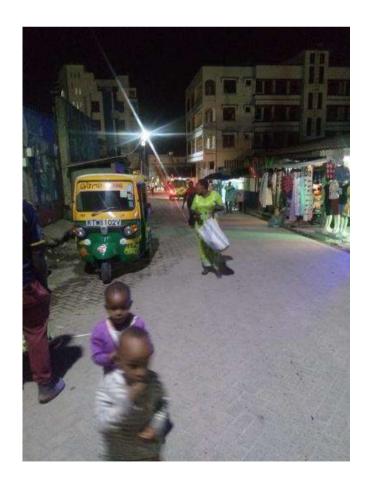
Image 9 showing shops on the street and presence of people

High boundary walls as shown in Images 7 and 8 can be found on stretches of Shimanzi Road which connects to Beira Road and Dedan Kimathi Road which connects to Kwale Road. The boundary walls acts as a barrier between the people on the street and built environment. It also results in making the street more inactive that instill a sense of fear in the pedestrians. Image 9 shows vendors on the street and the presence of women and children.

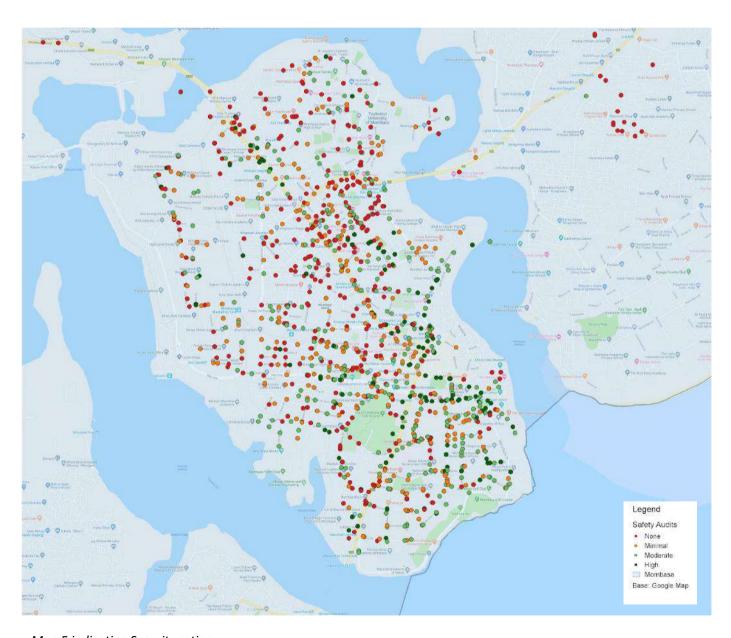
Map 5 indicating Security rating

Security for Mombasa has been rated 1.2/3 which is Average. 33% of the audit points have been given a low rating. To improve the security of the island, around the clock security should be provided at the locations that are least rated on security parameter.

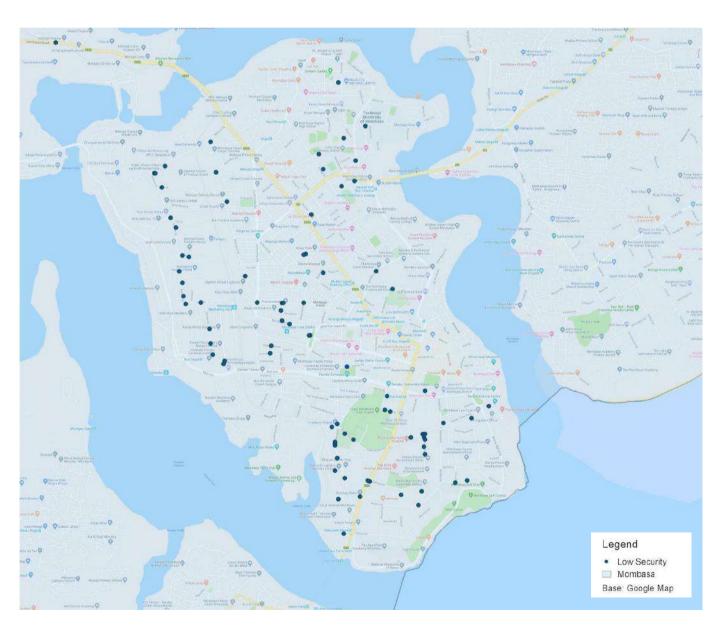
Map 6 indicating places with no natural or security surveillance

A total of 212 points were found to have a Poor rating for Visibility, which indicates the lack of "Eyes on the Street". Out of these, 87 points (41%) were found to have a Poor rating for Security. This relation between Visibility and Security can be seen in Map 6 below. Visibility, or "Eyes on the Street" is generally considered to be a natural surveillance on the street. So, the points in the map below show areas where there is no security surveillance or natural surveillance.

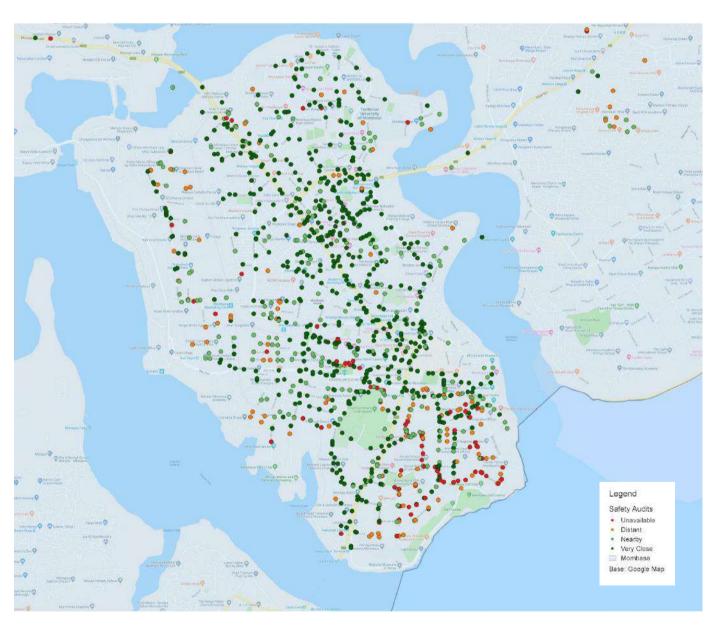
Map 7 indicating Public Transport rating

Public Transport in Mombasa has been rated 2.3/3 which is Good. As can be seen in the map, public transport is accessible in most parts of the city. The commonly used modes of public transport are matatus and tuk-tuks.

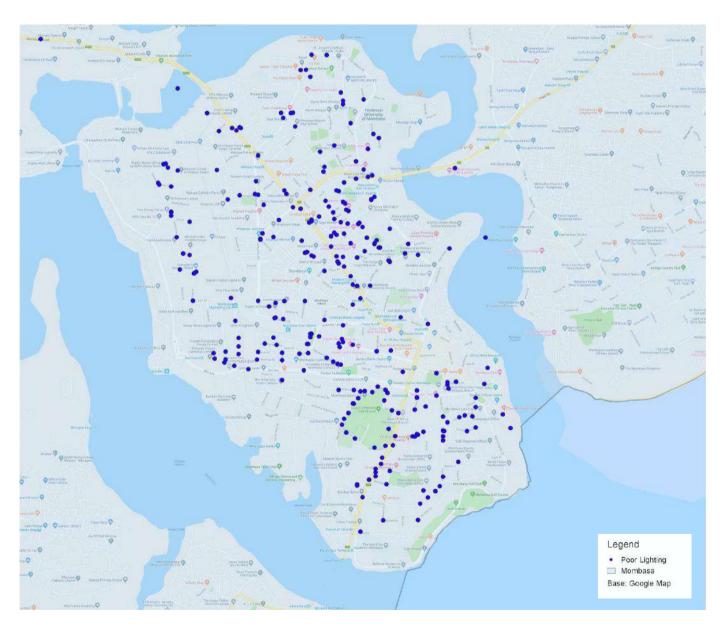
Map 8 indicating places with accessible Public Transport and low rating of Lighting

A total of 903 points were found to have a Good rating for Public Transport which indicates the ease of accessibility to different forms of public transport. Out of these, 279 points (31%) were found to have a Poor rating for Lighting. This relation between Public Transport and Lighting can be seen in Map 6 below. It is important to have proper lighting infrastructure in places with public transport stops and on the roads connecting them so that it is easy for people to move around safely.

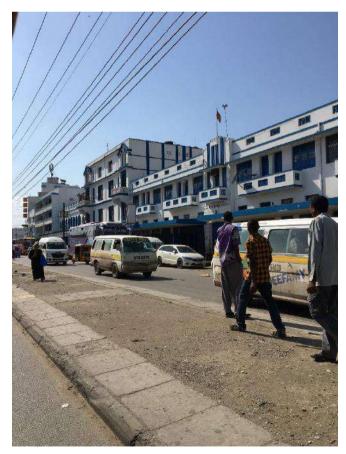
Image 14 showing public transport in the city

SNo.	Public Transport Issues	Recommendation
1	Poor infrastructure	The infrastructure at and around public transport stops should be improved. The shelters/stops should be properly lit and have proper street furniture for commuters who are waiting. This promotes more people to use public transport and improves the feeling of safety at the shelters/stops.
2	Parking infrastructure	The should be designated places for tuk-tuk stands so that people can easily access them. It is important to have parking facilities for the tuk-tuks so that they have a place to wait without interfering with oncoming traffic or obstructing the walkpath for pedestrians.

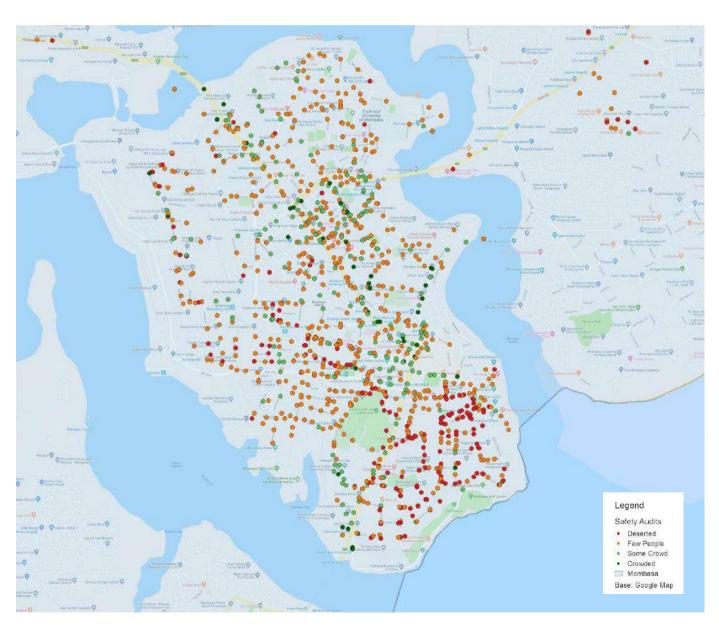
Map 9 indicating People rating

People for Mombasa has been rated 1.1/3 which is Poor. 17% of the points have been given a low rating and 58% have been given a Below Average rating. This shows that there is a lack of people in the public spaces of the island after dark. This points to the lack of activity on the streets post sunset.

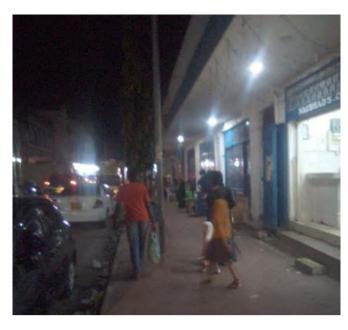
Image 15 showing people using the public spaces

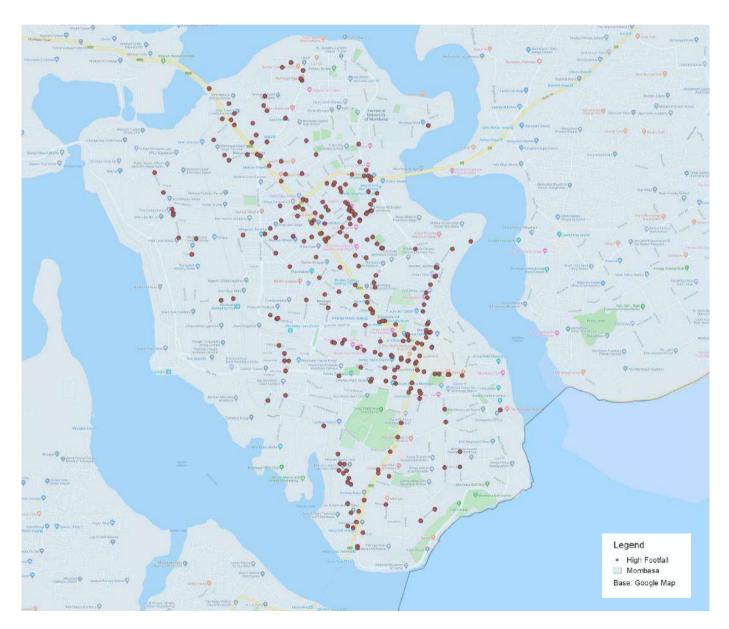
Map 10 indicating places with accessible Public Transport and high rating of People

There are over 900 points in the island where Public Transport has been rated Good. Out of these, 266 points (29%) have a Good rating for People. This relation between Public Transport and People can be seen in Map 8 below. This shows that at places where public transport is easily accessible, there are people, be it for commute or not. Since there are people present in these places, these should be given priority for infrastructure improvement.

The volunteers who conducted the safety audits have left comments on the poor maintenance of the lighting infrastructure at some of the points marked in the map below. This indicates that lighting infrastructure should be improved on priority.

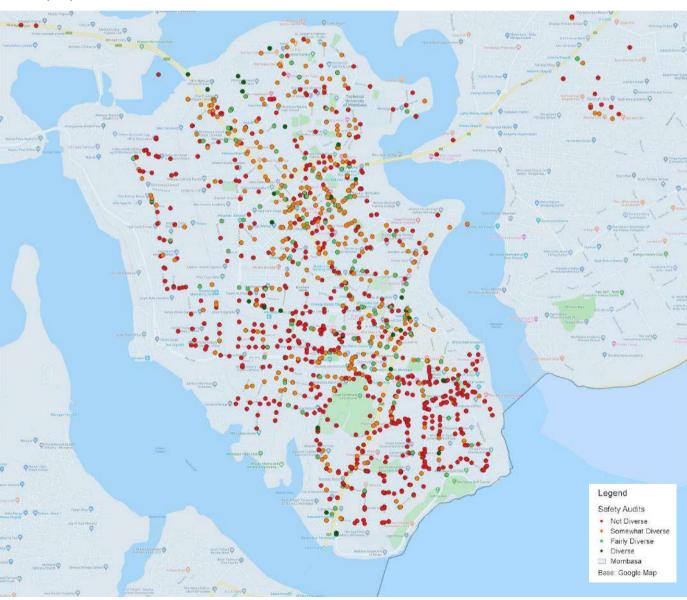
Map 9 indicating Gender Usage rating

Gender Usage for Mombasa has been rated 0.6/3 which is Poor. 53% of the audit points have been given a low rating. In most parts of the island, the number of people are also few, so the rating for Gender Usage is a two-fold problem that has to be addressed. The first is that there have to be more people out on the streets and in public spaces and the second that there has to be gender diversity within those people.

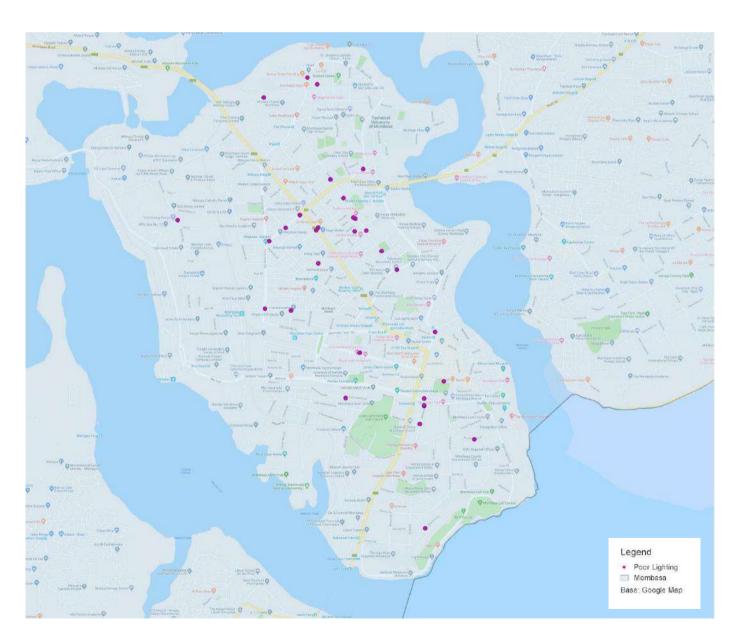
Map 11 indicating places with good gender diversity and low lighting

A total of 159 points were found to have a Good rating for Gender Usage which indicates the presence of women and children after dark. Out of these, 32 points (20%) have a Poor rating for Lighting. This relation between Gender Usage and Lighting can be seen in Map 10 below. Some of the comments received by the volunteers in these areas were that although there are streetlights present, they are not working or functional.

These identified spots should be dealt with on priority so as to promote more women and children to use the public spaces and make these spaces more active and lively. Lighting has been found to have a high impact on the feeling of safety and hence, should be addressed as a priority for infrastructure improvement.
